CASE STUDY

MICROGUIDE IDENTIFIES AREA OF SEVERE TORTUOSITY AT SIDETRACK KOP, ELIMINATING RISK OF STUCK PIPE INCIDENTS AND FAILED COMPLETIONS

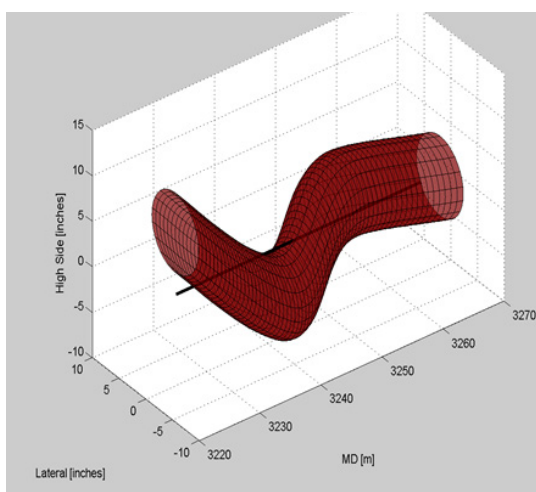
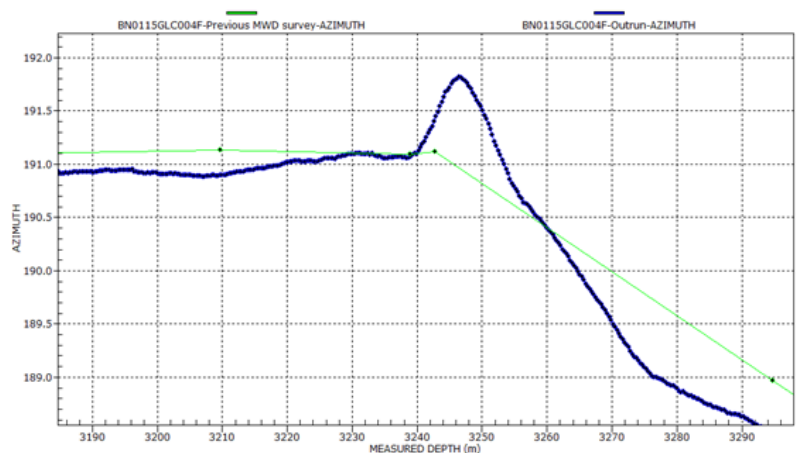
- Post-run analysis of the surveys with MicroGuide showed the kickoff point was extremely tortuous. In just a couple meters, the wellbore took nearly a 90° turn. Over a 50-m distance, it would be impossible to pass any straight object through without significant bending.
- Identifying this section of severe tortuosity allowed the operator to be mindful when tripping in or out of the hole. Without this knowledge, the operator would have faced multiple stuck pipe incidents or failed completions, which would have been extremely costly.
