## CASE STUDY

# MICROGUIDE REVEALS AREAS OF SEVERE SIDELOADING THAT CAUSED ARTIFICIAL LIFT EQUIPMENT FAILURE

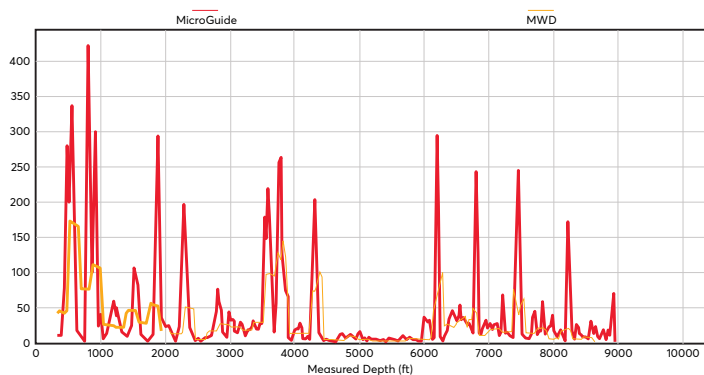
- After running the MicroGuide system in combination with a caliper log, we identified areas of significant sideloading throughout the well where the MWD data showed that there were no issues (**Fig. 1**).
- One area of sideloading at 8,244 ft was so severe that it had caused a rupture in the tubing, which was the root cause of failure (**Fig. 2**). The MWD data showed there was no concern for wear at that depth.

Fig. 1—Areas of high sideloading force were seen throughout the well with MicroGuide, while MWD data showed that sideloading was generally not a concern.

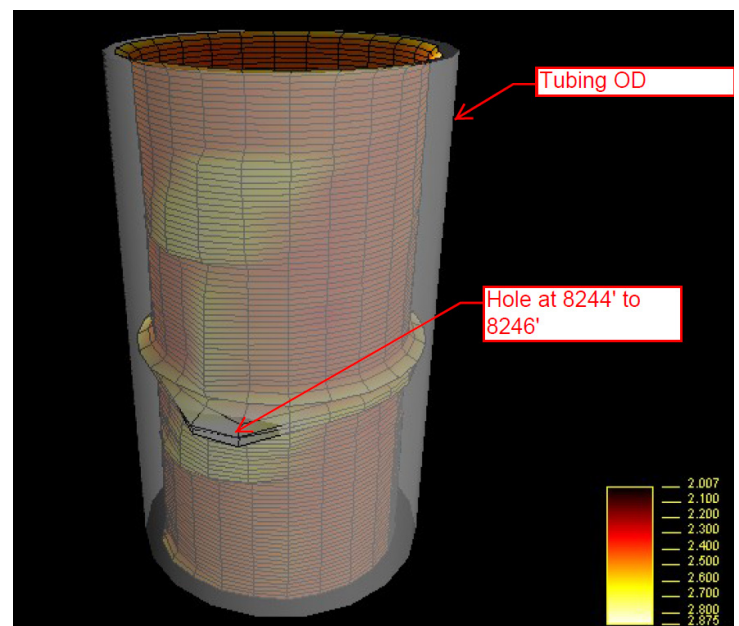
Fig. 2—The MicroGuide 3D wellbore visualization showed a hole from 8,244 to 8,246 ft, which was the cause of premature failure. Going only on MWD data, the operator never would have thought that the problem originated in this area.
