CASE STUDY

MICROGUIDE REVEALS TUBING AND CASING BUCKLING IN ARCTIC CIRCLE WELL CAUSED BY SUBSIDENCE

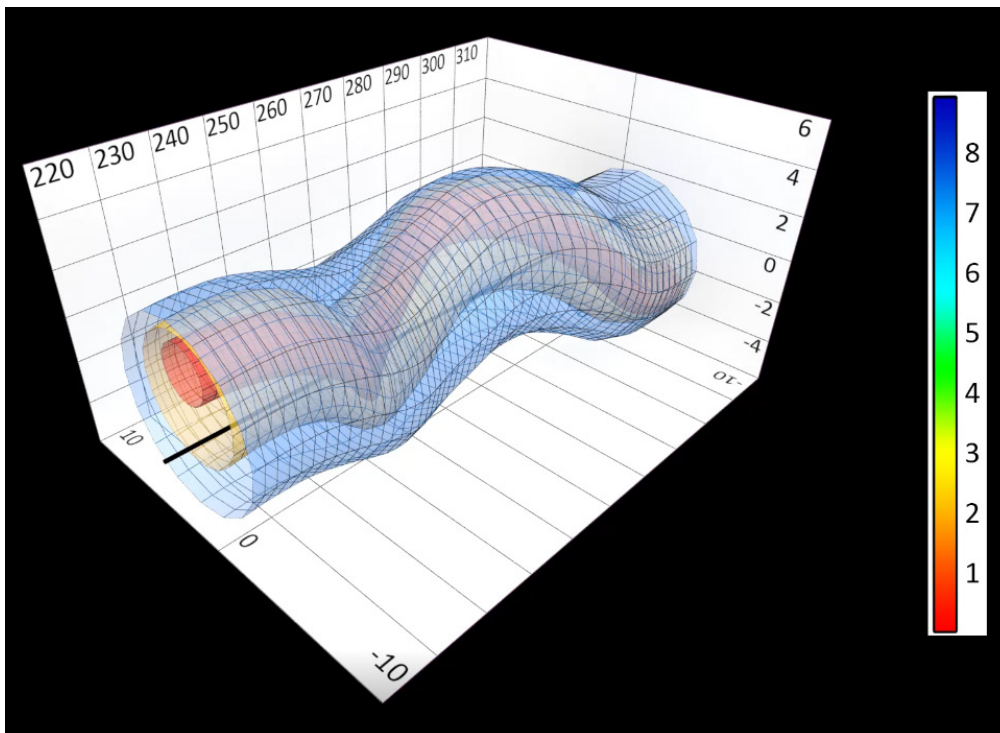
- The initial 2 $\frac{7}{8}$ -in. tubing survey showed a spike in measured inclination at approximately 270 ft down.
- While the MWD survey data showed a standard well path without issues, the MicroGuide logs told a different story. Buckling was occurring not only in the 2 $\frac{7}{8}$ -in. tubing but also in the 7- and 9 $\frac{5}{8}$ -in. casing.
