CASE STUDY

MICROGUIDE REVEALS SEVERE TORTUOSITY AND HELICAL BUCKLING IN WELLBORE THAT WAS CAUSING ARTIFICIAL LIFT EQUIPMENT FAILURE

- Bakken Shale

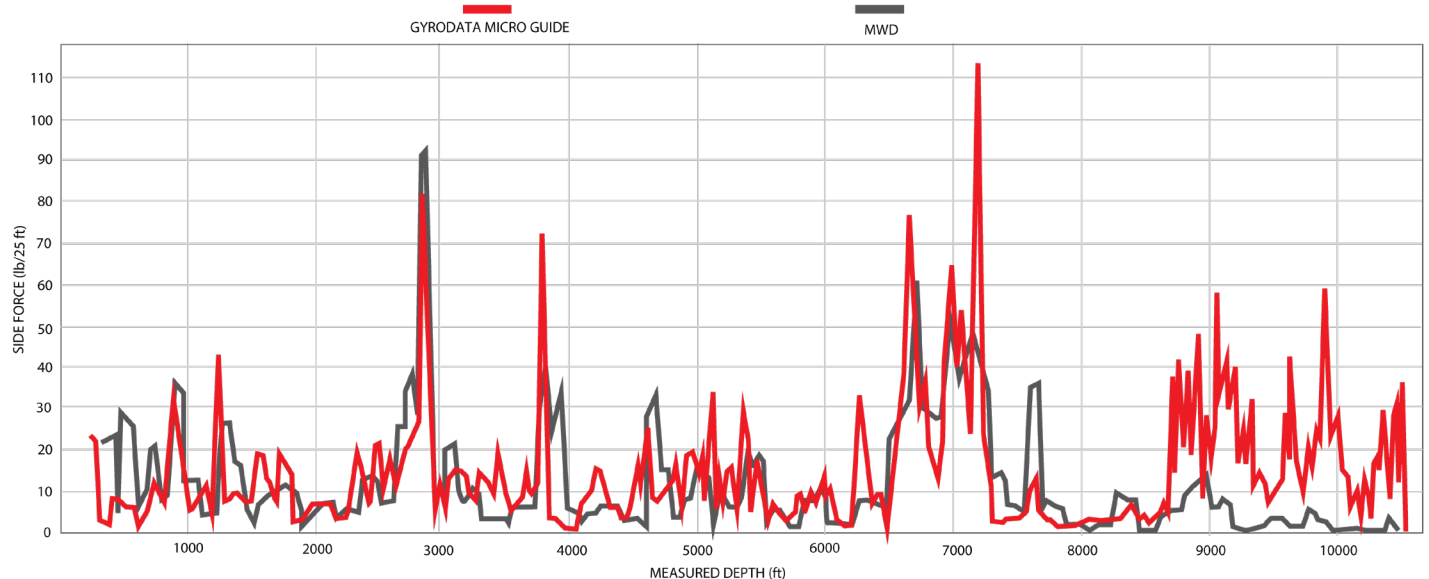
- The MicroGuide analysis revealed several severe spikes in sideloading force against the tubing that were not previously visible with MWD data (**Fig. 1**).
- The analysis showed that the casing was helically buckled from 8,700 to 10,560 ft, which was causing the increased sideloading force throughout the section as well as the issue with rod guide parting.
- Without the MicroGuide logs, the operator would have had inadequate data on the bottom hole to properly make decisions on the best artificial lift method.

Fig. 1—The data from the MicroGuide logs shows several tortuosity spikes not picked up with the MWD tools, as well as a concerning area from 8,700 to 10,560 ft.
