CASE STUDY

MICROGUIDE REVEALS SIDELOADING SPIKE IN PROBLEM SECTION, ALLOWING OPERATOR TO ELIMINATE ROD PUMP FAILURES

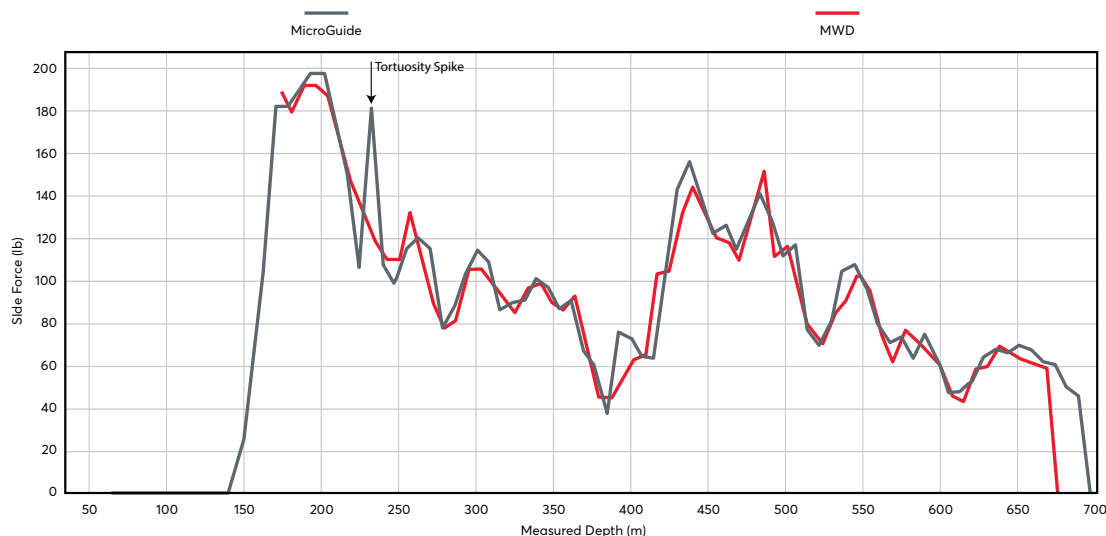
- We then ran our MicroGuide wellbore tortuosity logs to obtain true insight into downhole conditions. The MicroGuide logs revealed a spike in sideloading force at approximately 235-ft MD that wasn't visible in the MWD data. The operator confirmed that this was the area where they had the last three rod breaks and understood that the increased drag was the root cause of failure.

- After reviewing the information further, the operator was able to develop a plan to extend the coverage of their co-rod string to include the entire build section, mitigating the issue and eliminating future failures.
