CASE STUDY

MICROGUIDE REVEALS TORTUOSITY SPIKES AND LATERAL DISCREPANCY VERSUS COMPETITOR GYRO SYSTEM

MicroGuide[™] wellbore tortuosity logs

Permian Basin (Eddy County, New Mexico)

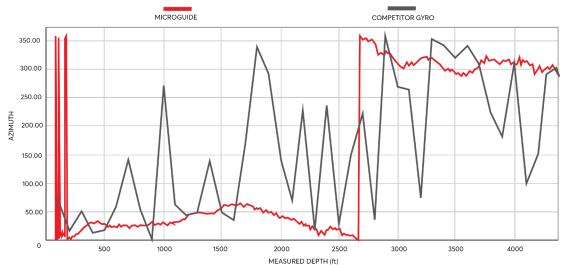
- The MicroGuide data showed that the well was straight down to the the kickoff point and that there was no bending down to approximately 4,370 ft. The original survey data had more than a dozen incorrect azimuth readings (Fig. 1), which would have led to the operator taking a costly and unnecessary approach to placing the rod guides.
- □ The MicroGuide data showed significant variance in tortuosity versus the competitor gyro data, with our system showing that the competitor had measured incorrect tortuosity spikes in almost every survey (**Fig. 2**).
- □ The MicroGuide data revealed a lateral discrepancy of 27 ft (Fig. 3) versus the original gyro surveys, further proving the lack of quality data.

Fig. 1—The graph shows the clear differences in azimuth readings between the original gyro surveys and the MicroGuide logs throughout the well.

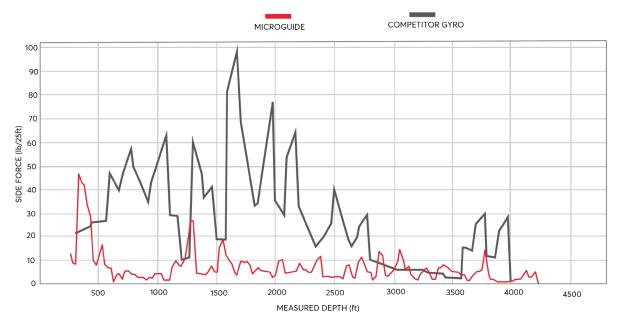
Fig. 2—The MicroGuide analysis showed that virtually every sideforce measurement calculated with the competitor gyro was incorrect, which would have led to the operator wrongly believing they needed specialized equipment to place production equipment.

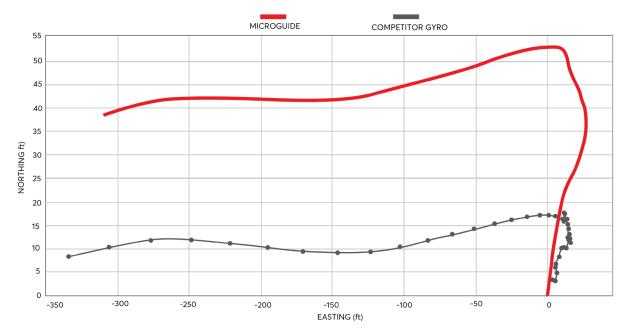
Fig. 3—The MicroGuide logs revealed that in the original survey data, there was a lateral discrepancy of 27 ft versus the actual wellbore placement.
