## CASE STUDY

# MICROGUIDE REVEALS CAUSE OF FAILURE AT PREVIOUS ESP LOCATION AND PROVIDES RECOMMENDATION FOR NEW PLACEMENT

- Artificial lift
- ESP placement

- Permian Basin (Reeves County, Texas)

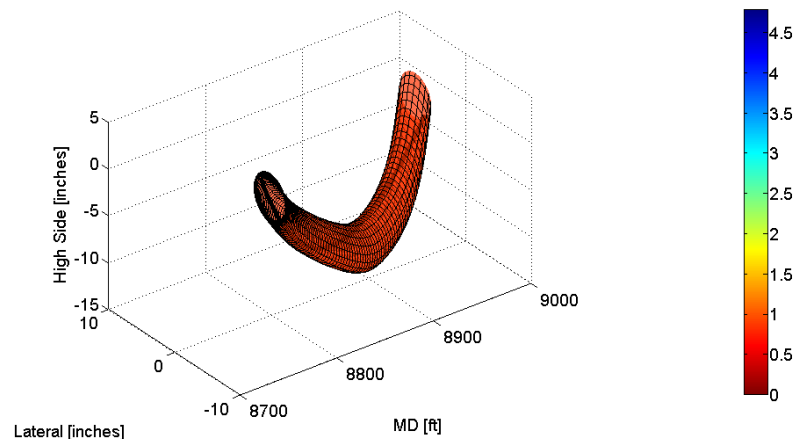
- The MicroGuide data revealed that at the original set depth of 8,874 ft, there was an area where the effective diameter dropped to .84 inches (**Fig. 1**). This is what caused the first pump to fail, highlighting the challenge of placing artificial lift equipment with limited data on wellbore conditions.

3D representation of transversal displacement. Color temperature is proportional to the maximum diameter of device in inches.  
At a Measured Depth of 8874.0 ft, the maximum diameter of a device is 0.84 inches, at a device bend of 1.540 degrees / 100 ft.  
For a device of diameter 4.00 inches, a uniform bend below the allowed maximum was not found.

Fig. 1—The original ESP placement caused premature failure due to its location in an area where the effective diameter dropped to less than an inch.

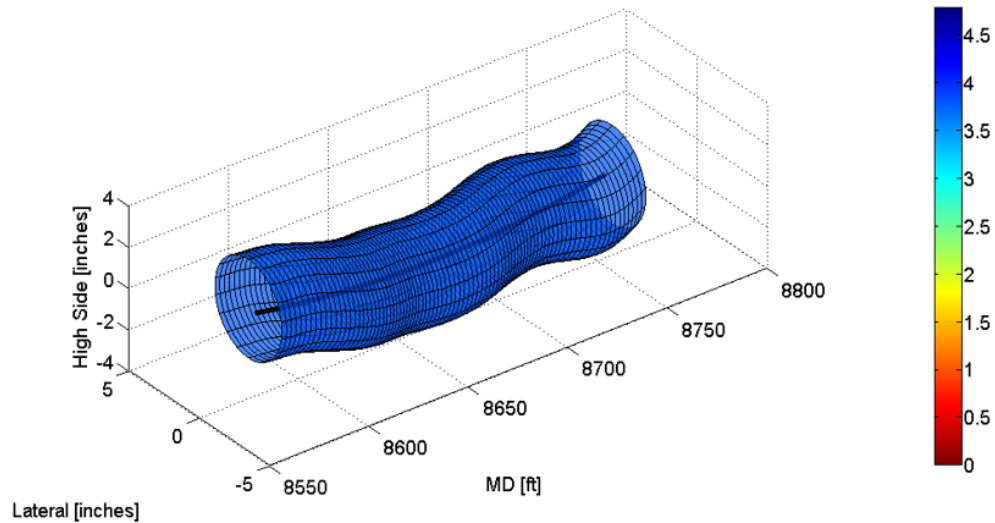
- We found that at the operator's proposed set depth of 8,666 ft, the maximum effective diameter of a 176-ft pump was 3.78 in., which was below the pump diameter of 4 in. and could lead to another failure in the future (**Fig. 2**).

3D representation of transversal displacement. Color temperature is proportional to the maximum diameter of device in inches. At a Measured Depth of 8666.0 ft, the maximum diameter of a device is 3.78 inches, at a device bend of 0.099 degrees / 100 ft. For a device of diameter 4.00 inches, a uniform bend below the allowed maximum was not found.

Fig. 2—At the operator's proposed set depth, there was much less tortuosity in the well, but the pump would still fail as there was no uniform bend below the allowed maximum.

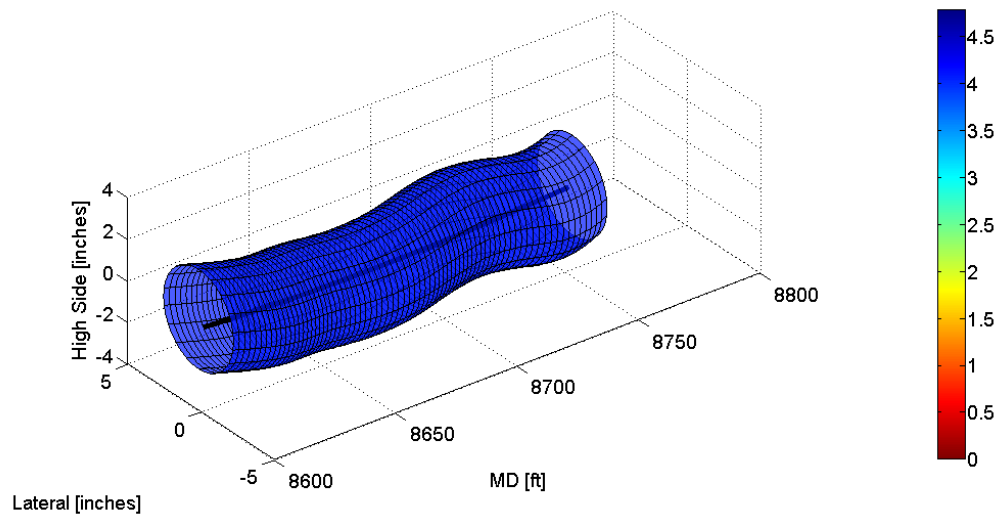
3D representation of transversal displacement. Color temperature is proportional to the maximum diameter of device in inches. At a Measured Depth of 8676.0 ft, the maximum diameter of a device is 4.08 inches, at a device bend of 0.150 degrees / 100 ft. A device of diameter 4.00 inches will undergo a uniform bend of 0.100 degrees / 100 ft.

Fig. 3—At our suggested set depth and with a shorter pump, it would be possible to place the ESP without risk of premature failure.

- Though we were able to recommend several alternative set depths with maximum effective diameter closer to 4 in., there was no perfect area to place the ESP within 2,000 ft of the operator's proposed set depth. As such, we recommended they use a shorter pump (150 ft), which would allow for a maximum effective diameter at our suggested set depth of 8,676 ft (**Fig. 3**).
