CASE STUDY

MICROGUIDE IDENTIFIES TORTUOUS AREAS IN WELLBORE, ENABLING OPTIMIZED ESP PLACEMENT AND ELIMINATING PREMATURE EQUIPMENT FAILURES

MicroGuide[™] wellbore tortuosity logs

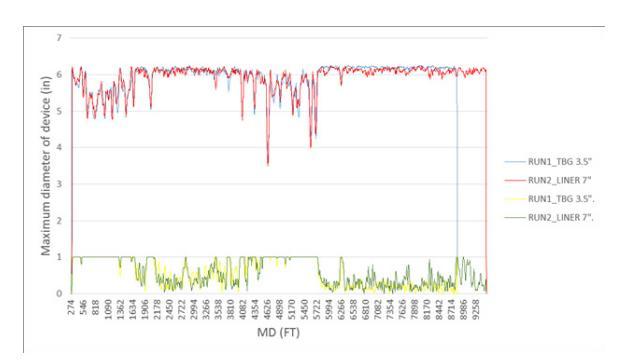
The MicroGuide analysis showed that from 250 to 2,000 feet and 4,000 to 6,000 feet, tortuosity was severe enough to present a problem with proper ESP placement. Additionally, the analysis revealed that in these locations, the maximum diameter of a straight device would be less than the 5.62-in. OD of the ESP. These results were confirmed with both sets of data providing the client with extra peace of mind and quality control.
