# MICROGUIDE REVEALS SEVERE WELLBORE TORTUOSITY, ENABLING OPTIMIZED ESP PLACEMENT AT NEW WELL DEPTH

MicroGuide<sup>™</sup> wellbore tortuosity logs

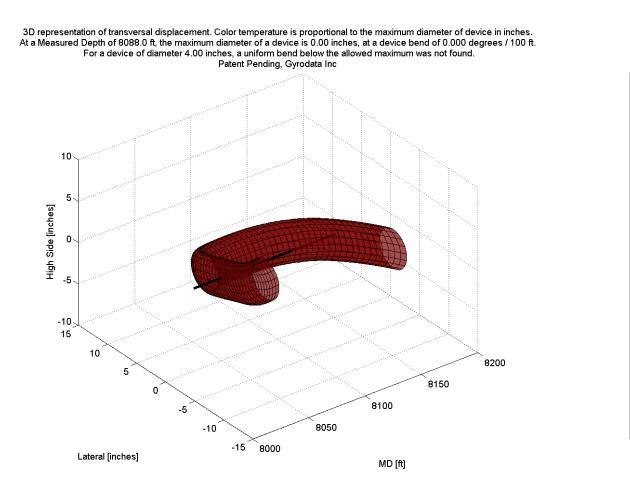
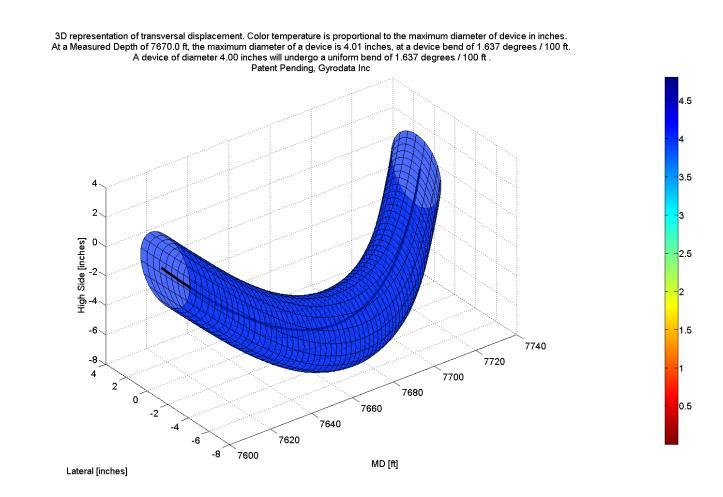
- □ We collected high-resolution tortuosity data via a MicroGuide analysis, which displayed tortuosity, total displacement, maximum diameter of the straight device, and 3D wellbore graphics.
- □ Using the MicroGuide tortuosity analysis, we determined that the optimal location for the new pump was between 7,610 and 7,732 ft based on the effective diameter.
- □ At an MD of 7,670 ft, the maximum diameter that would allow a uniform bend was 4.00 in. at a device bend of 1.637°/100 ft.
