## CASE STUDY

# MICROGUIDE REVEALS BHA PERFORMANCE LIMITATIONS, ENABLES OPTIMIZED ESP PLACEMENT IN CHALLENGING WELL

- MicroGuide™ wellbore tortuosity logs

- Artificial lift
- ESP placement

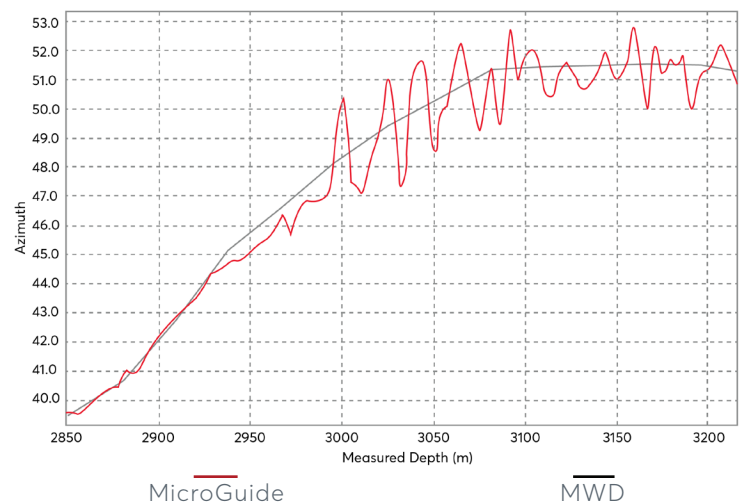
- While examining the MWD sensor readings revealed no evidence of gross error, the well had not been drilled as expected, which was shown on the MicroGuide logs.
- The operator had already incurred costs of more than \$7 million from lost time and damaged equipment, but the MicroGuide system identified microdoglegs in the casing not picked up by the MWD surveys with data collected at stand-length intervals.
- The wellbore tortuosity data revealed the performance limitations of the existing BHA and helped the operator determine that optimal placement of the ESPs was 492 ft higher in the wellbore to avoid further damage.

- The well was initially drilled with an RSS and surveyed with a drop gyro and MWD system down to 8,875 ft. MWD surveys were only collected to TD at 10,750 ft. The MWD surveys on the last 1,312 ft showed that with regards to azimuth, inclination was building from 58 to 70° over the section. However, there were indications of issues with the 12<sup>1</sup>/<sub>4</sub>-in. BHA on the trip out of hole, making backreaming from 10,794 to 9,104 ft and hole cleaning from 10,794 to 10,354 ft necessary.
