CASE STUDY

MICROGUIDE ANALYSIS REVEALS SEVERE SIDELOADING FORCES AGAINST THE TUBING THAT WERE CAUSING ROD STRING FAILURE

- MicroGuide™ wellbore tortuosity logs

- Bakken Shale

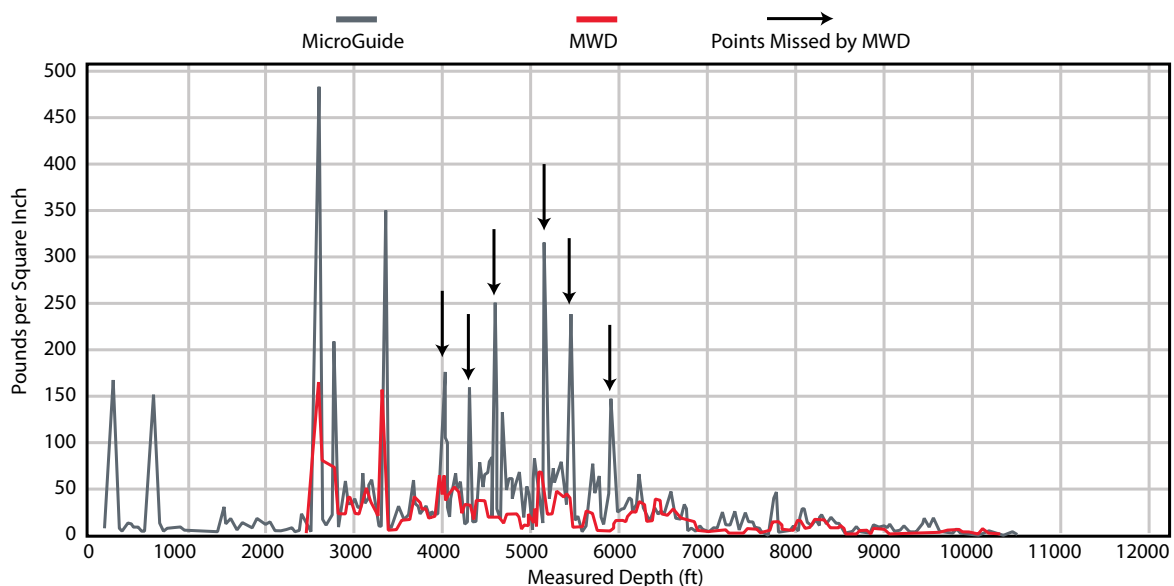
- After obtaining our MicroGuide logs, the operator obtained data that was previously entirely missing from the surveys between 0 and approximately 2,700 ft.
- The MicroGuide logs revealed that there was significant sideforce against the tubing from 2,500 to 5,550 ft, indicating that the root cause of failure was severe tortuosity.
- Understanding the issue and true wellbore conditions allowed the operator to develop a plan to address the problem and prevent its occurrence in future well design.
