CASE STUDY

MICROGUIDE REVEALS MWD ERROR AND SEVERE TORTUOSITY SPIKES, ALLOWING OPTIMIZED PUMP PLACEMENT

MicroGuide™ wellbore tortuosity logs

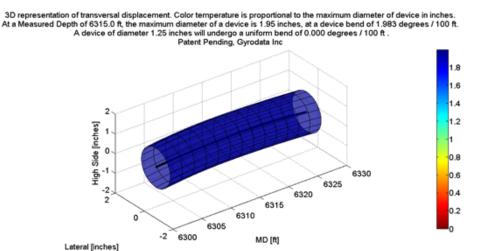
- □ The MicroGuide logs revealed that the 31° dogleg was in fact an error from the MWD tool, and that there was no tortuosity in the first 4,550 ft of the well.
- □ The logs also revealed that past the 4,550-ft point, the well was extremely tortuous due to the large build and drops. We recommended caution when traversing the areas of high tortuosity to place the pump, helping ensure the equipment wasn't damaged.
- Based on our analysis, the operator was able to successfully place the pump in a tortuosity-free area in the 2¾-in. tubing at 6,315 ft. This position was determined as the location where production could be optimized while minimizing equipment wear.
