CASE STUDY

MICROGUIDE REVEALS INCORRECT TORTUOSITY SPIKES IN MWD DATA, ALLOWING OPERATOR TO PROPERLY PLACE ESP

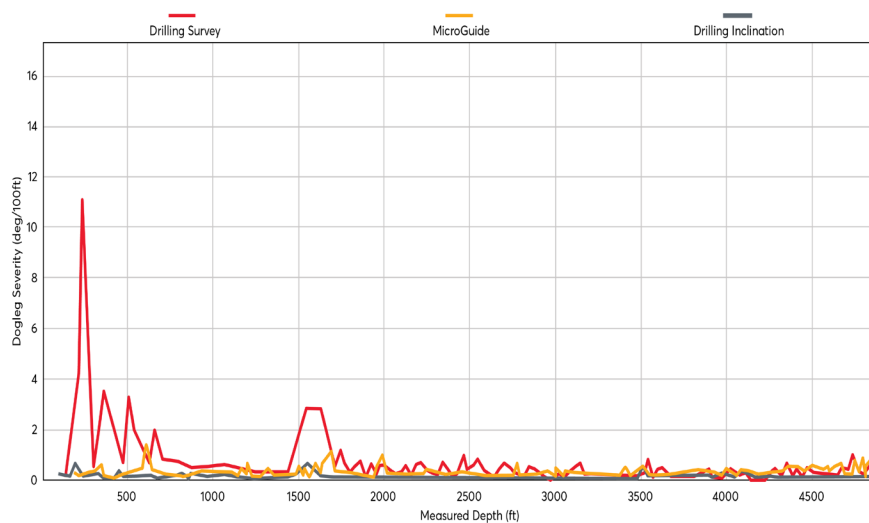
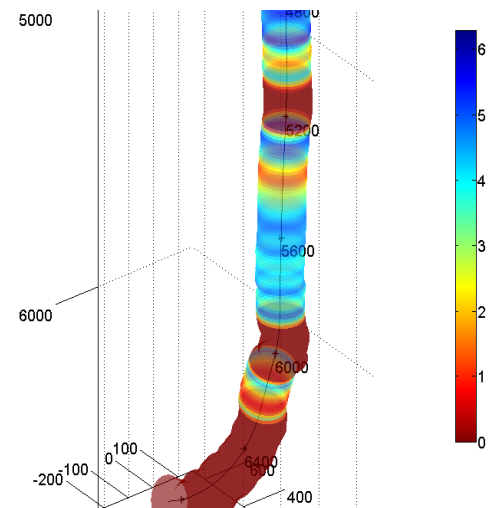
- After obtaining detailed information from the MicroGuide logs, we determined that several spikes in wellbore tortuosity reported by the MWD data in the first 1,000 ft of the well were incorrect. We also noted two other incorrect spikes near 1,500-ft MD.
- Having this data meant that the operator could more effectively plan proper placement of the pump, as they wouldn't wrongly believe that there was a difficult-to-traverse area in the shallowest parts of the well.
- We provided an optimal set depth based on the MicroGuide analysis of 5,600-ft MD. We validated this placement with a 3D visualization verifying that there was tortuosity deeper in the well that would make placing the ESP difficult or impossible.
