CASE STUDY

MICROGUIDE REVEALS UNSEEN TORTUOSITY AND AZIMUTH ANOMALIES, ALLOWING OPTIMIZED ESP PLACEMENT

- MicroGuide™ wellbore tortuosity logs

- Artificial lift
- ESP placement

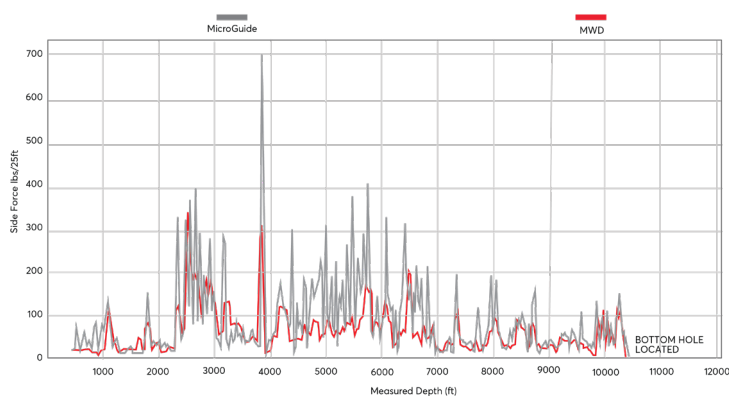
Fig. 1—The MicroGuide logs indicated that there was tortuosity throughout the well that had been undetected by the original MWD surveys.

- The MicroGuide logs revealed previously unseen tortuosity from approximately 2,400 to 6,500 ft (Fig. 1), allowing the operator to place the ESP in an optimized location downhole. Ongoing monitoring of the well has shown that the operator has eliminated any premature failures.
- The MicroGuide data revealed that in the upper part of the hole, there was an erroneous azimuth reading on the MWD survey (Fig. 2) that caused an incorrect spike in DLS. Had the operator used this information, they would have incorporated additional equipment at greater cost to traverse the section there not being significant DLS in that area.
- We also provided the operator with a modeled rod guid analysis, which will be used when production from the ESP declines and they change their artificial lift method.

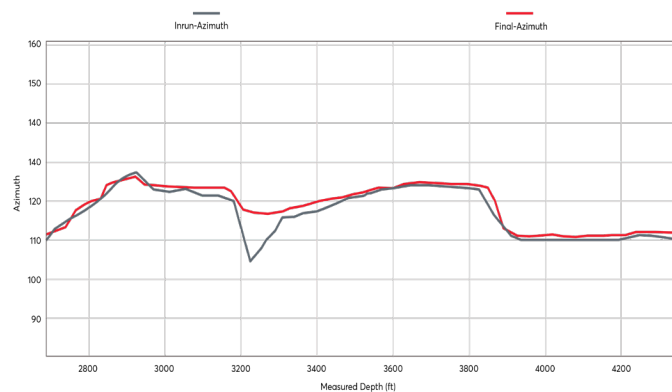
Fig. 2—The erroneous azimuth reading in the MWD data versus the true azimuth as shown with the MicroGuide logs.
