CASE STUDY

MICROGUIDE LOGGING IDENTIFIES ISSUES WITH PREVIOUS SURVEY AND DISCOUNTS TORTUOSITY AS THE CAUSE OF PREMATURE PUMP FAILURES

- MicroGuide™ wellbore tortuosity logs

- Identifying cause of ESP failures
- ESP placement

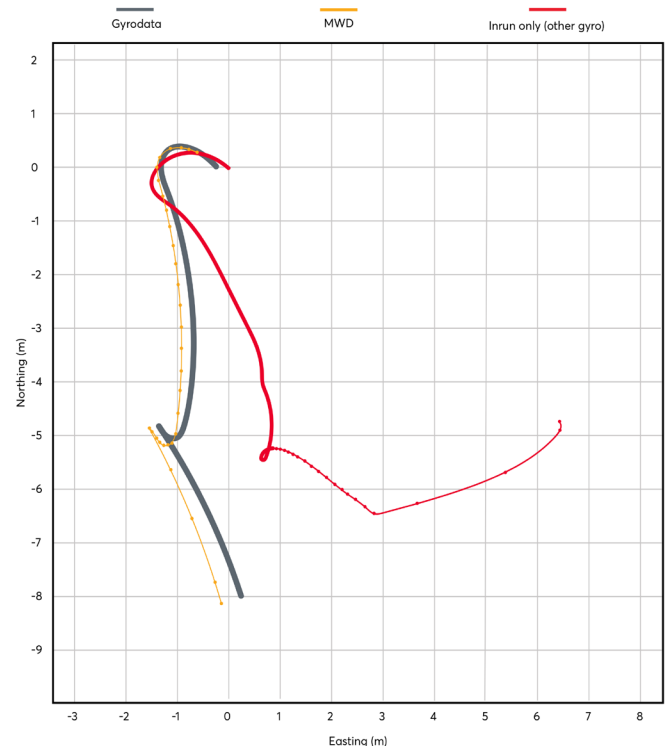
- The Gyrodata survey compared favorably with original MWD survey, confirming the MWD was accurate / reliable
- Gyrodata log revealed it was the previous gyro inrun survey that was inaccurate / unreliable, (with large discrepancies between its inrun and outrun, the outrun survey was rejected/discarded)
- Gyrodata results indicated very low tortuosity and allowed more optimal, deeper setting of the ESP
- The operator was able to demonstrate to the ESP provider that the wellbore quality was not causing the premature failures (as had been implied)
