CASE STUDY

MICROGUIDE REVEALS ERRORS IN MWD DATA, PREVENTING OPERATOR FROM ABANDONING THE WELL OR IMPLEMENTING UNNECESSARY ARTIFICIAL LIFT SYSTEM AND SAVING MORE THAN \$100,000

- MicroGuide™ wellbore tortuosity logs

- Bakken Shale

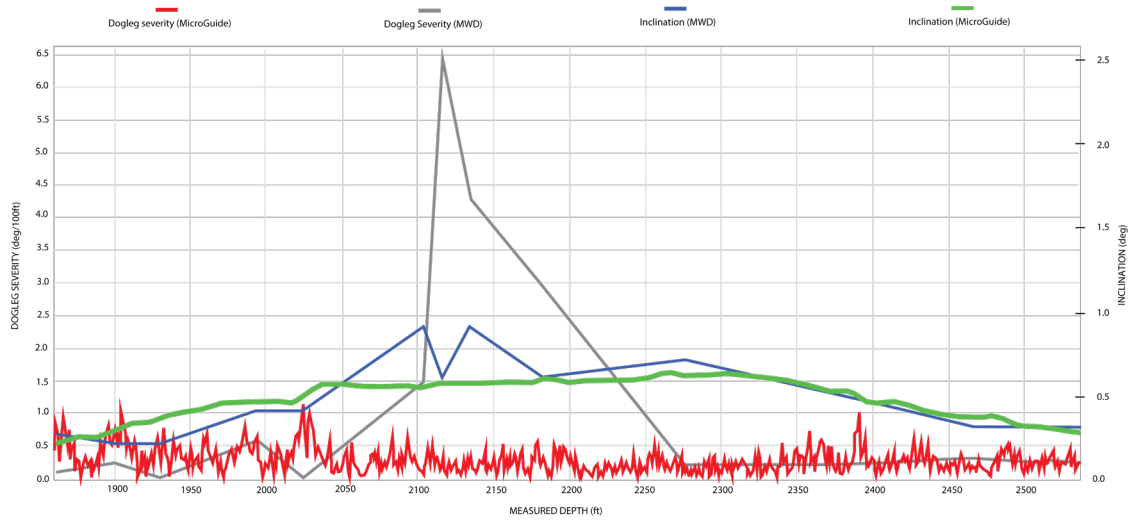
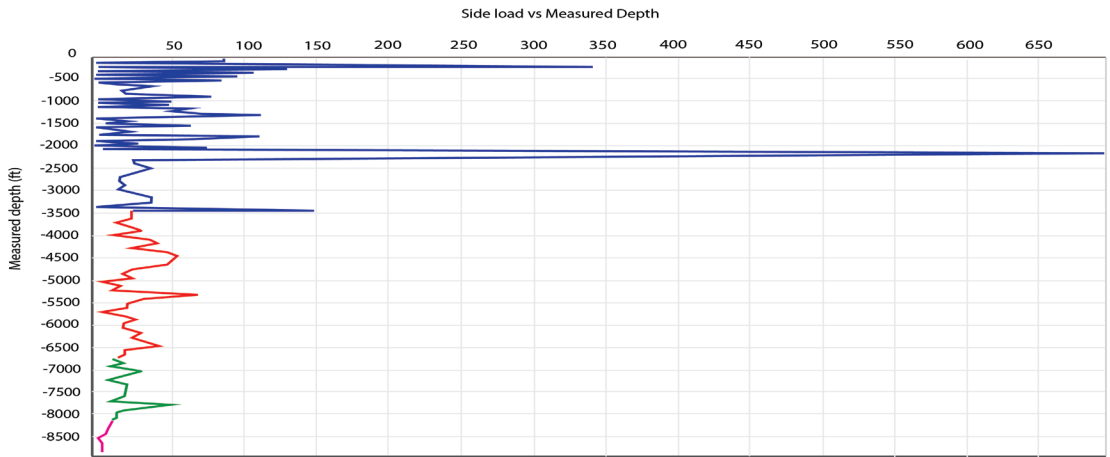
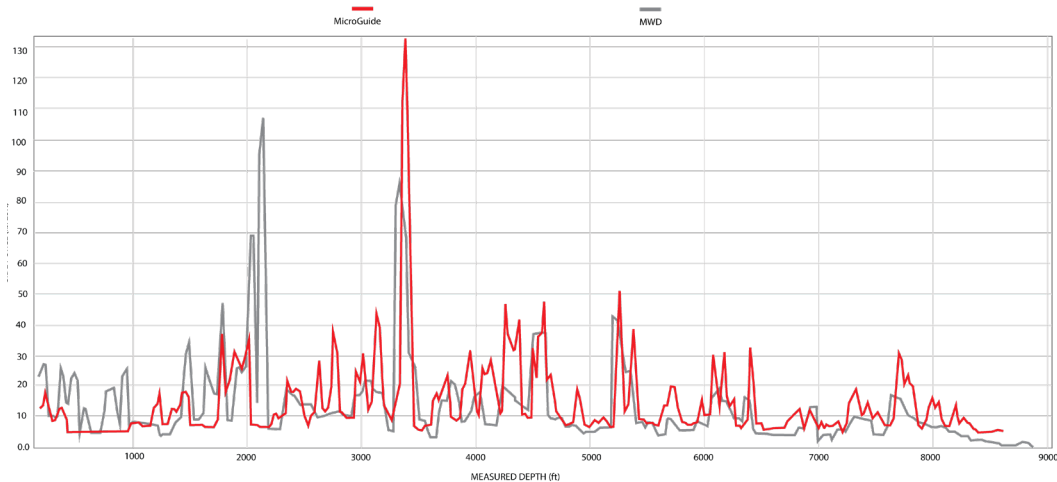
- After running our MicroGuide logs, we found that there was incorrect MWD data throughout the surface section that showed larger sideforce than was actually present. In particular, several incorrect data points were showing false dogleg severity and sideloading readings—some at approximately 1,250 lb/ft—at 2,116 ft.
- Had the operator used the MWD data instead of performing the MicroGuide analysis, they would have either abandoned the well (100% production loss) or changed it to plunger lift to account for the extreme sideforce, which would have cost more than \$100,000 and reduced production by almost 90%.
- Having detailed wellbore tortuosity data in production casing from MicroGuide provided insight into true downhole conditions, ensuring that the operator implemented the correct artificial lift system at an optimal depth to maintain production.
